# Wits study investigates why Jagersfontein dam failed

Six months after the Jagersfontein tailings dam in the Free State failed - killing one person and destroying multiple homes - civil engineers at the University of the Witwatersrand (Wits) have used satellite and aerial imagery to investigate what went wrong.

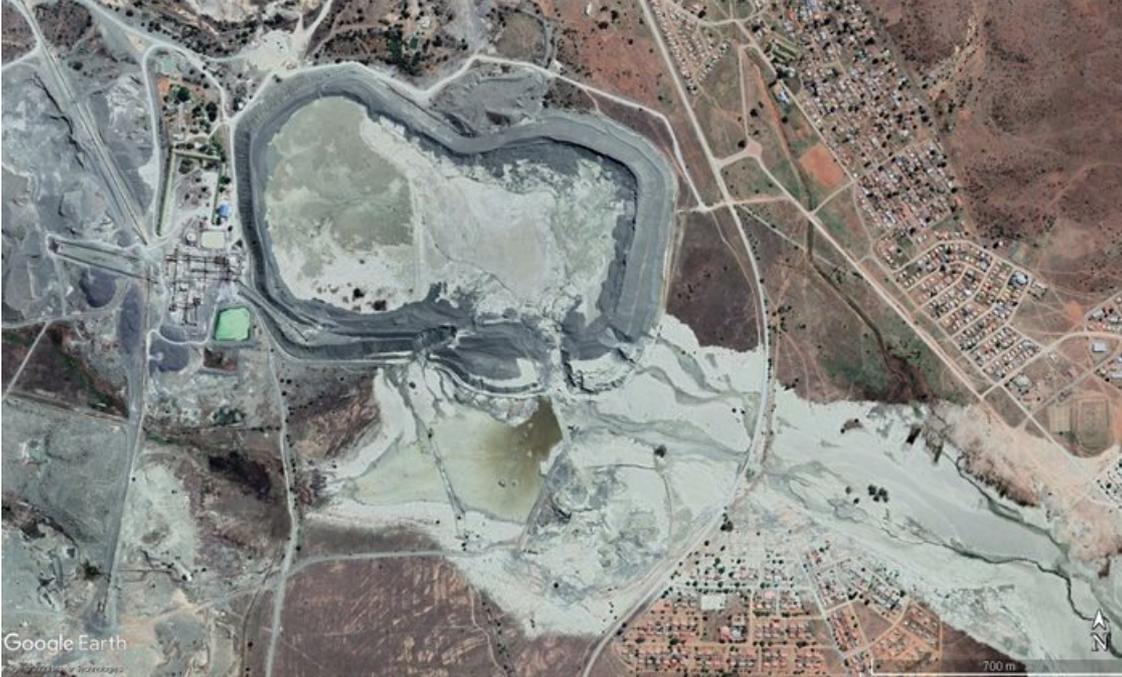
Post-failure satellite image of the Jagersfontein dam. Source: Google Earth Pro

The study found that the history of the Jagersfontein dam deviates from best engineering practice. The deviations include mine waste deposition from predominantly one side of the dam, erosion gullies on the dam wall, and significant amounts of ponded water at times positioned against the retaining structure.

Based on the analysed images, the study hypothesises that percolation of water through the dam, followed by external

erosion, ultimately triggered instability.
